Palace Road Estate Structural Inspection Report

Prepared by

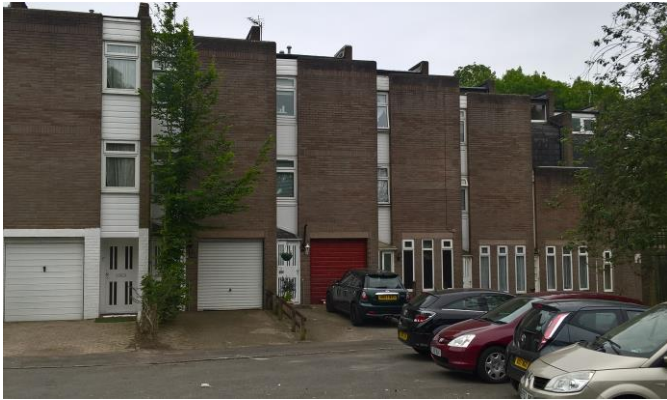
Coburg Crescent – front elevation

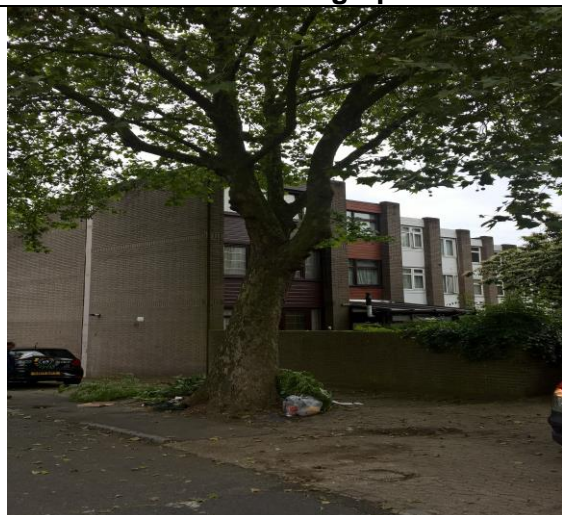
Mature London Plane tree – in front of Flat NO.10

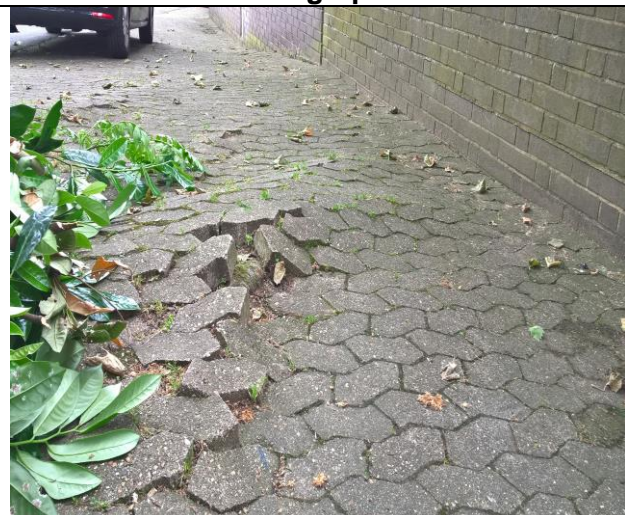
Lifting and uneven block work due to expanding root system

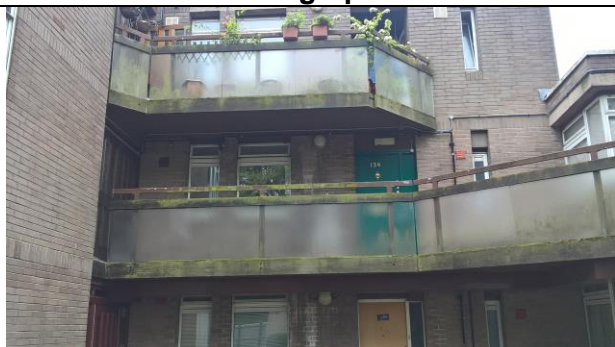
Coburg Crescent 130-139

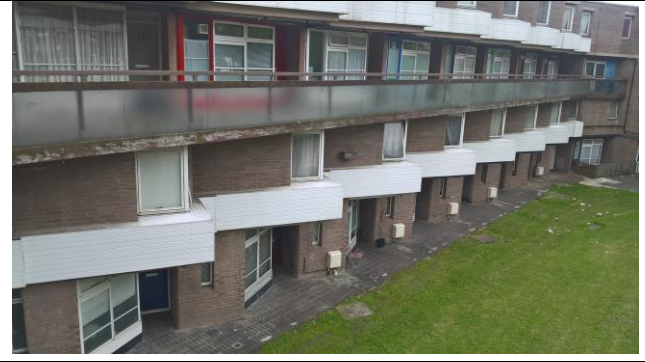
Typical Railings to Private balcony (Maisonettes)

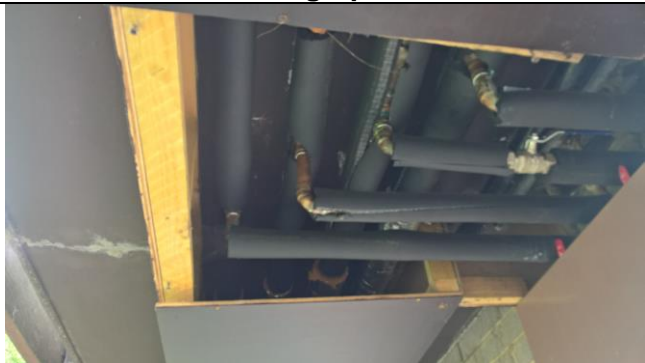
Exposed service pipes serving flats.

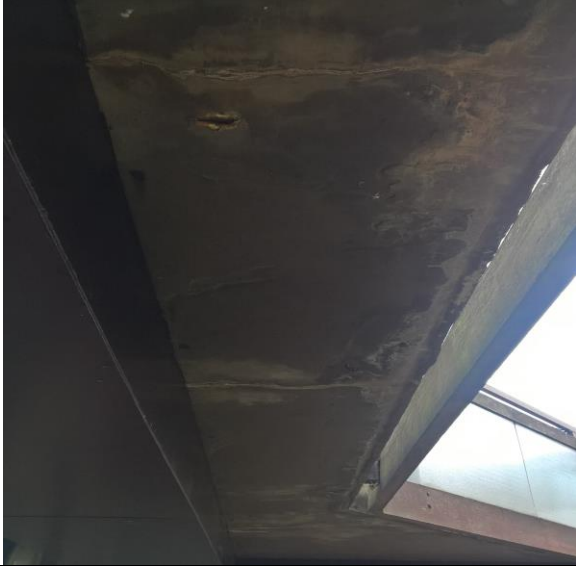
Cracks on communal balcony soffit and service duct to full length.

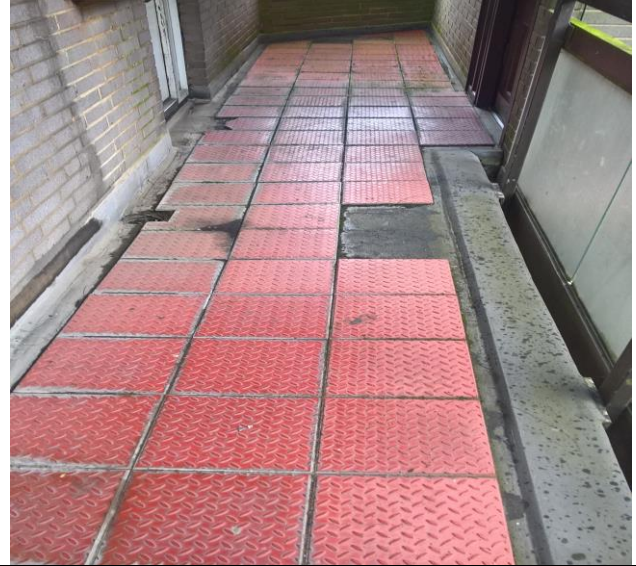
Clay tile laid over old asphalt waterproofing (Despard House Flats & Maisonettes)

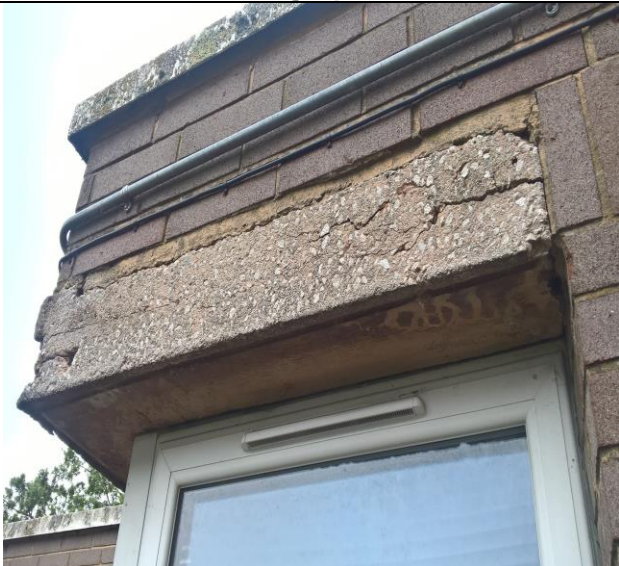
Cracked concrete to lintel-beam

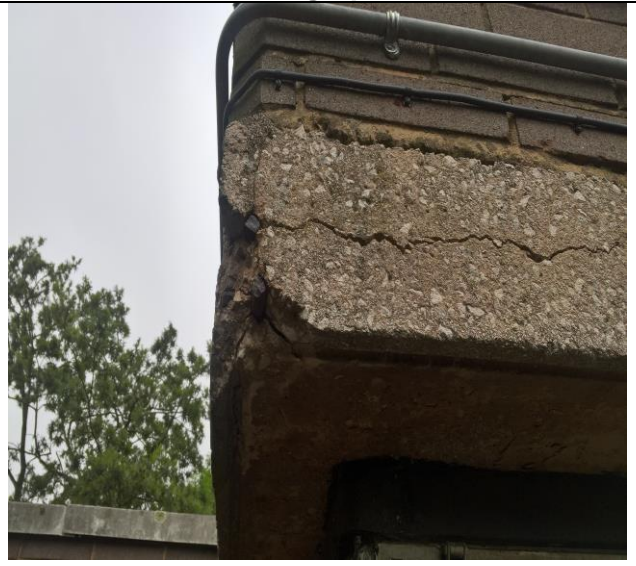
Corroded and exposed reinforcements to lintel-beam due to detached concrete

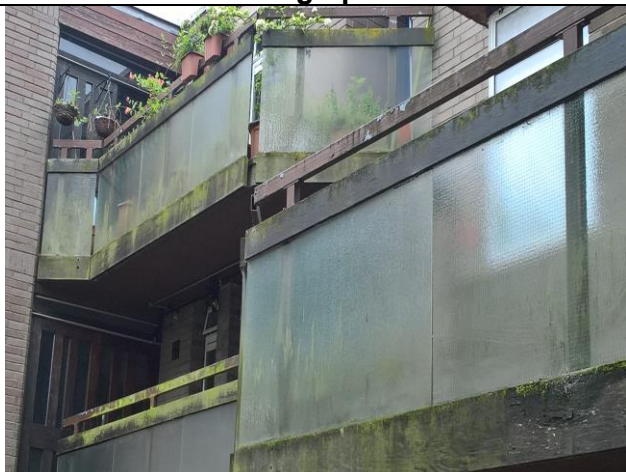
Peeling & flaking paintwork to railings timbers

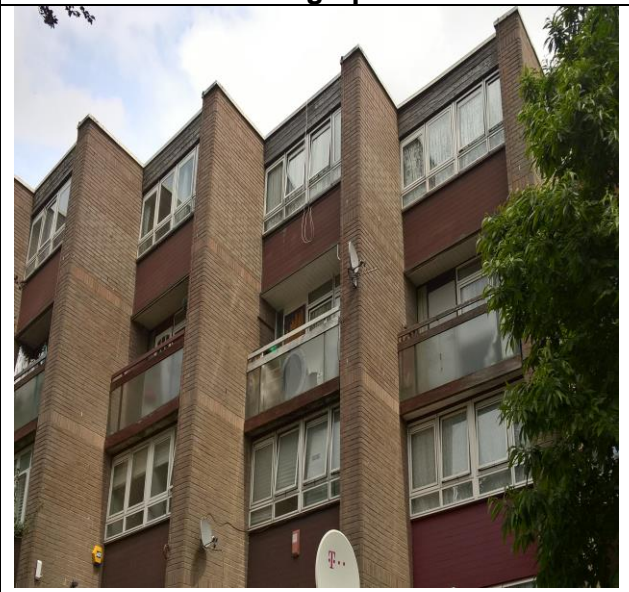
Maisonette – Typical Rear Elevation

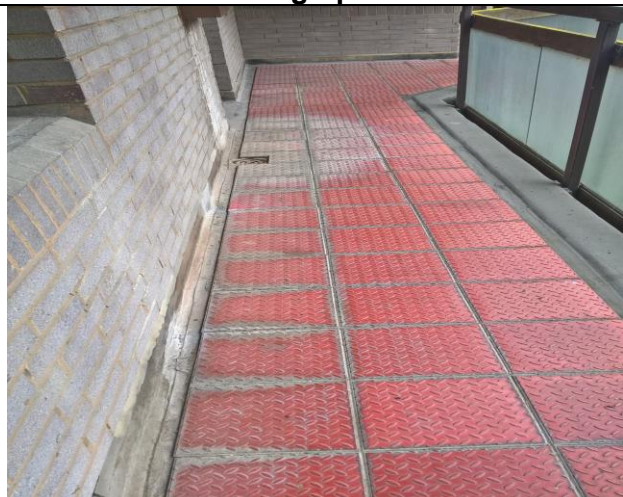
Clay tiles laid over asphalt waterproofing layer

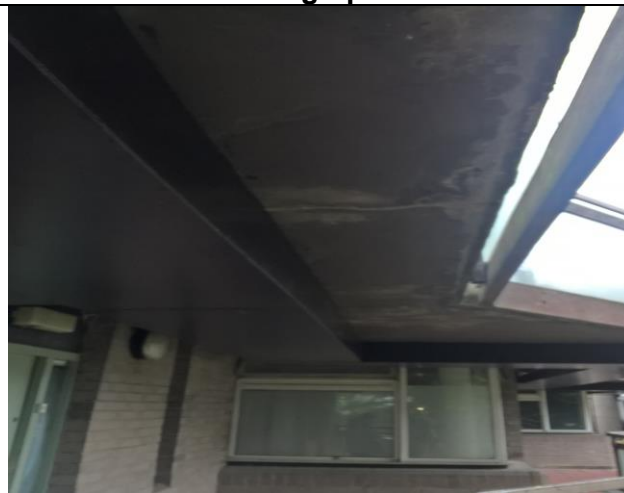
Horizontal cracks & water stains in the soffit

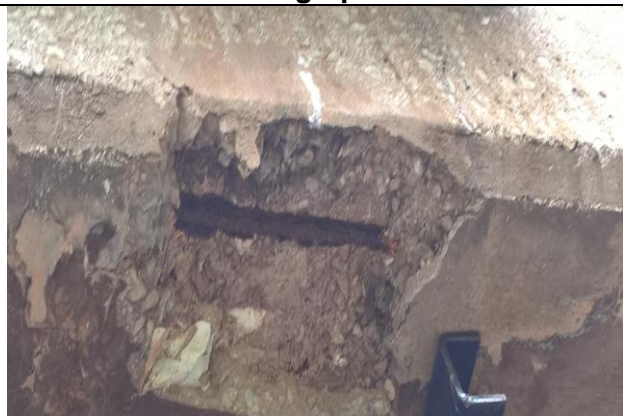
Detached concrete to leading edge of slab

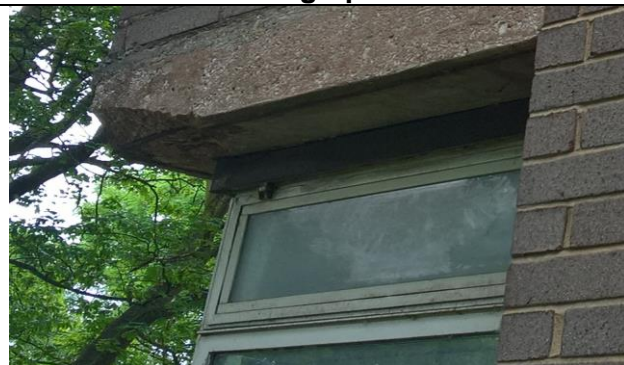
Exposed corroded reinforcement in leading edge

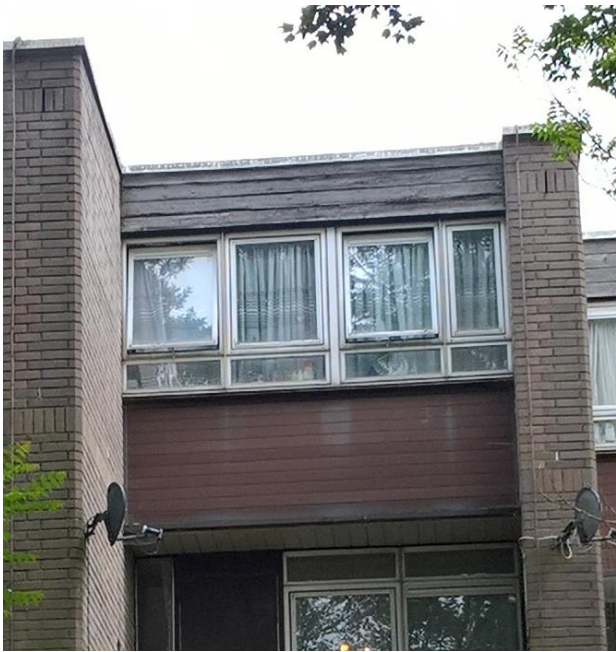
Flaking & Peeling paintwork to timber cladding to maisonette

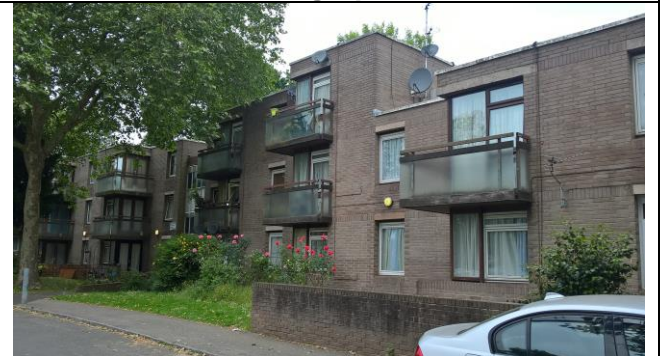
Chalner House –Rear Elevation

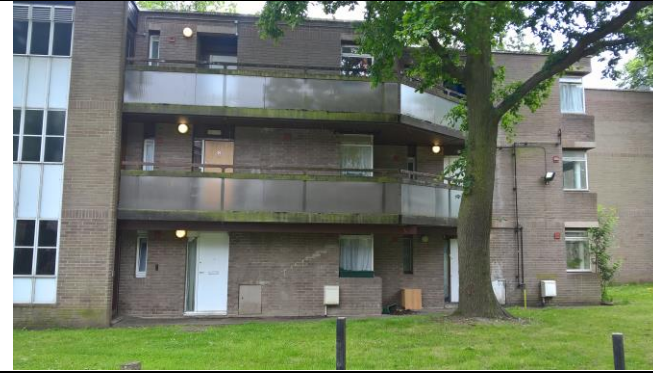
Mature Oak in front of flat-2

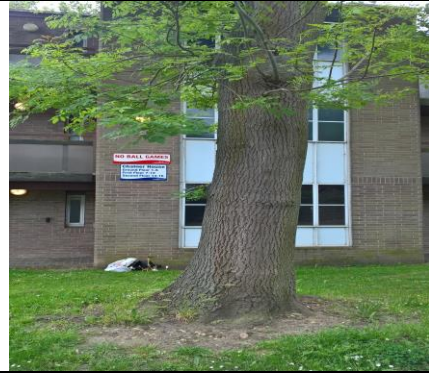
Ash tree in front of staircase

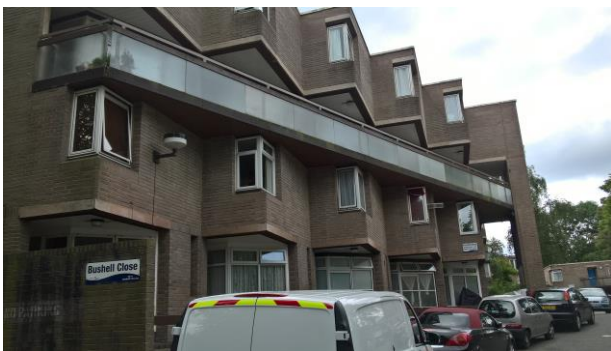
Part front elevation

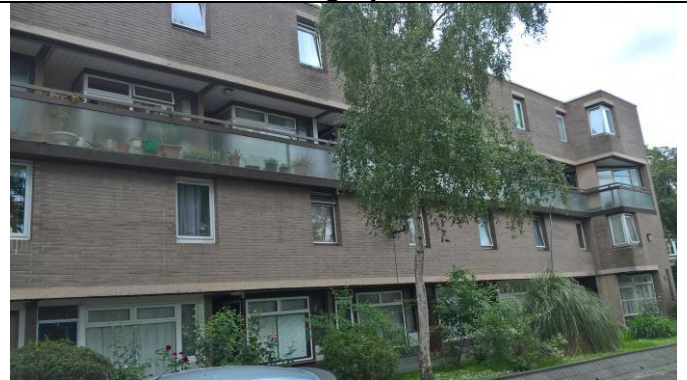
Part front elevation

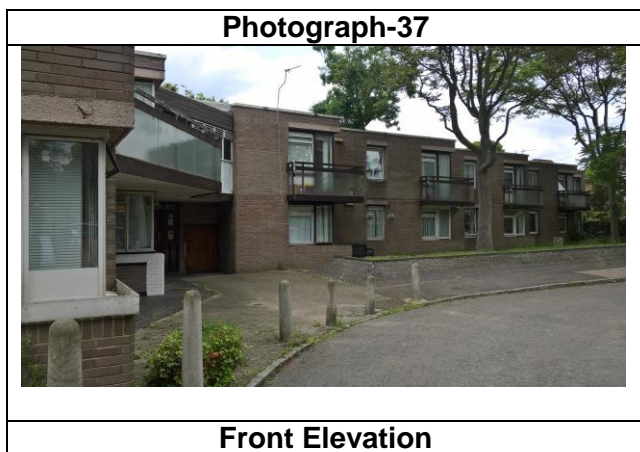
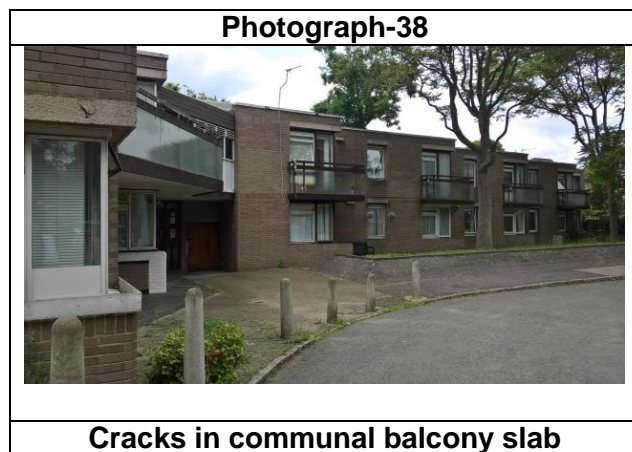
- a) This is a ground and 2nd floor single block of maisonette structurally similar to other maisonettes in the estate (see photograph -37). The brickwork on all elevations appeared to be in good condition.
- b) Three minor horizontal cracks were observed on the soffit to the communal balcony slab (see photograph -38).
