## PALACE ROAD ESTATE

I carried out a 'walk around' on the Palace Road Estate on 4<sup>th</sup> June 2018, for the purpose of ascertaining the level and extent of the External Major works required on the estate. The address list is attached as Appendix A.

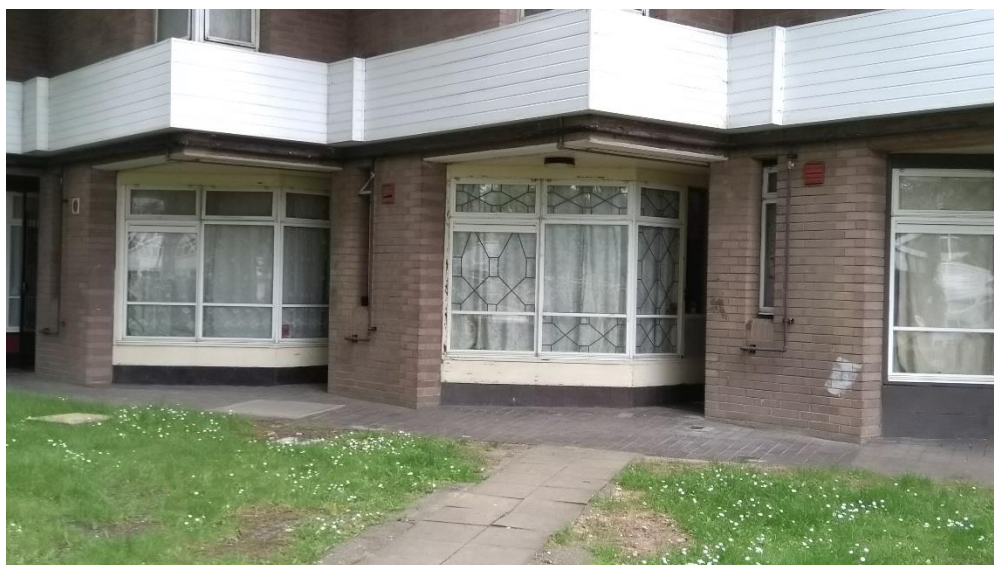
- It is assumed that the flat roofs will need total replacement, with upgrading of the thermal efficiency.
- Window replacement will be required, including Patio/balcony doors

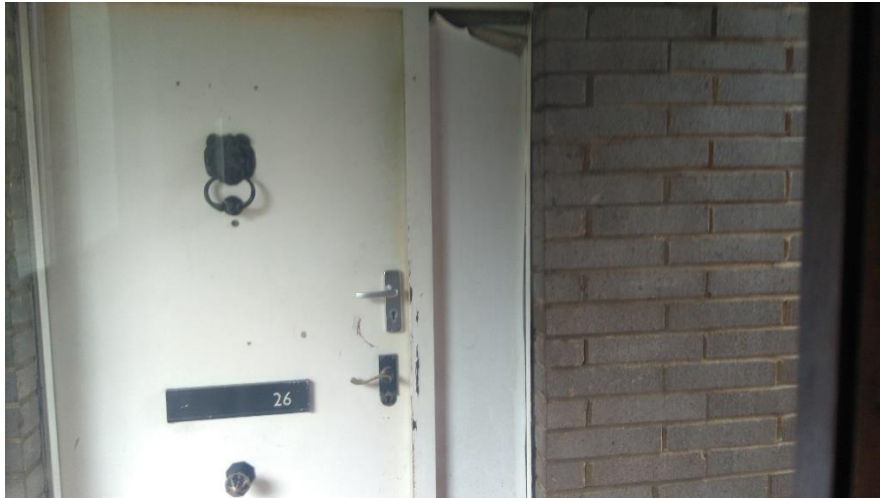
- All front entrance doors to tenanted flats will require upgrading to Fire check doors and doorsets

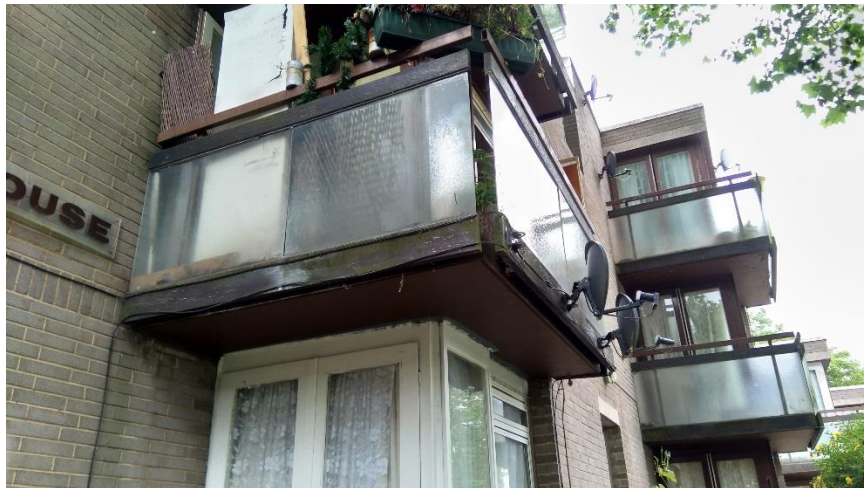
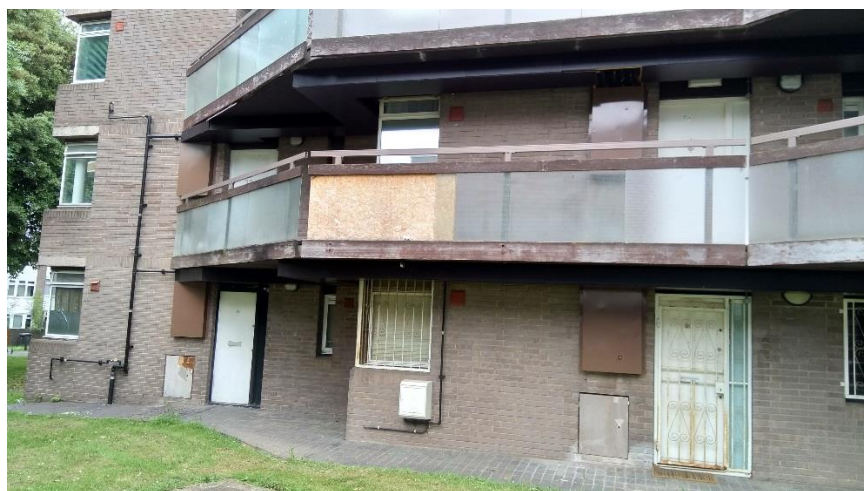
- All balconies require significant repairs, including timber replacement and replacement or alternative glazing.

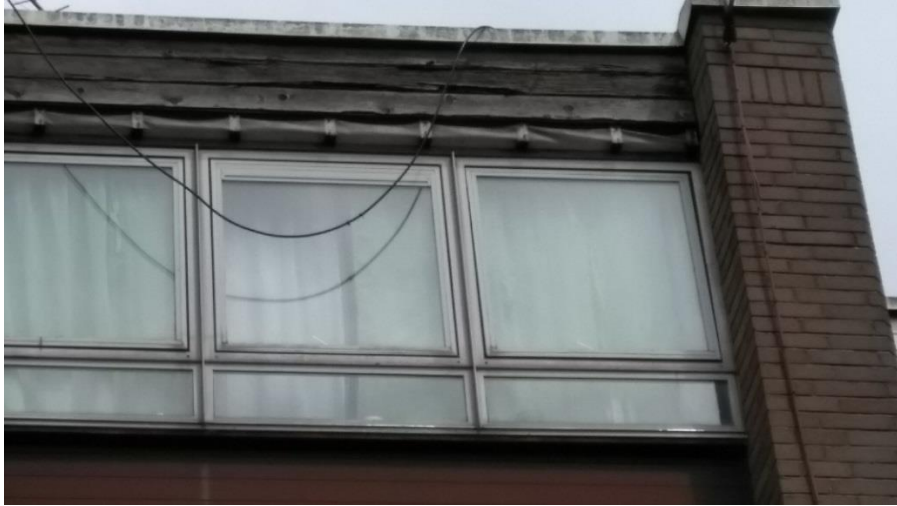
- There is timber cladding between and above windows which is in poor condition

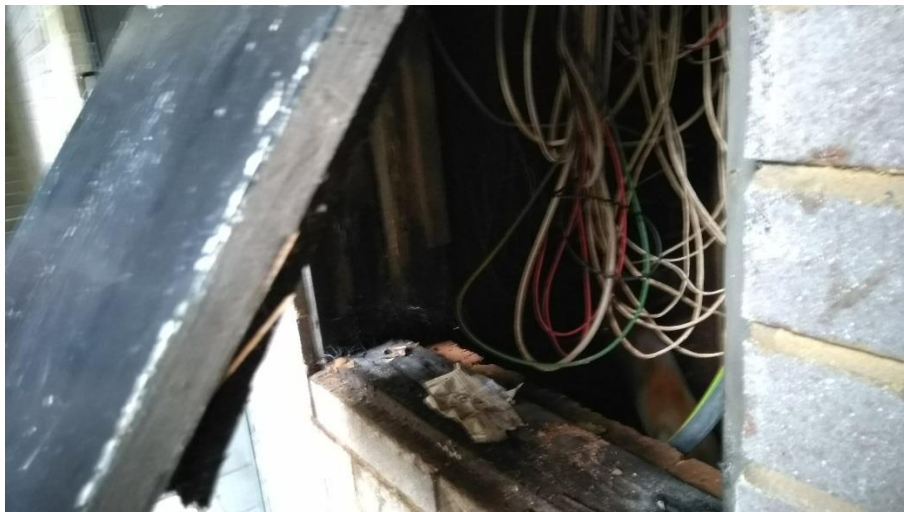
- The internal areas are mainly brick faced, however there are FRA related works in respect of replacing the plywood ducting panels

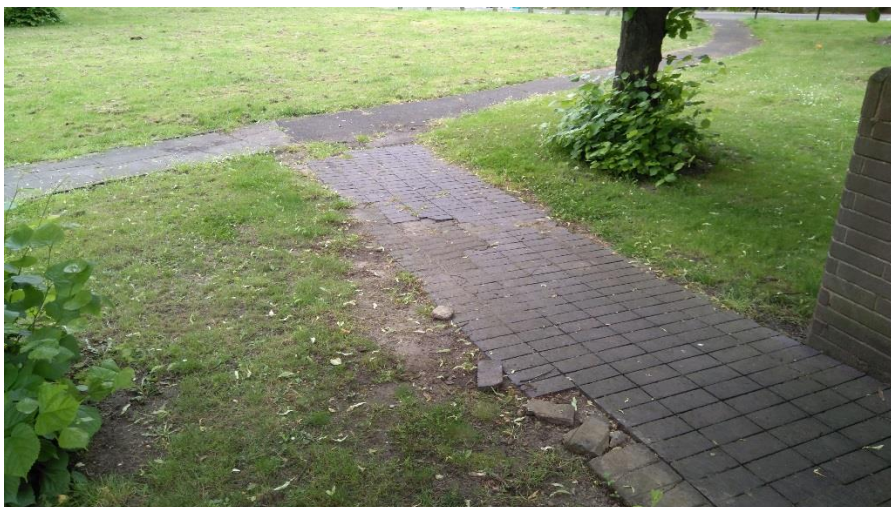
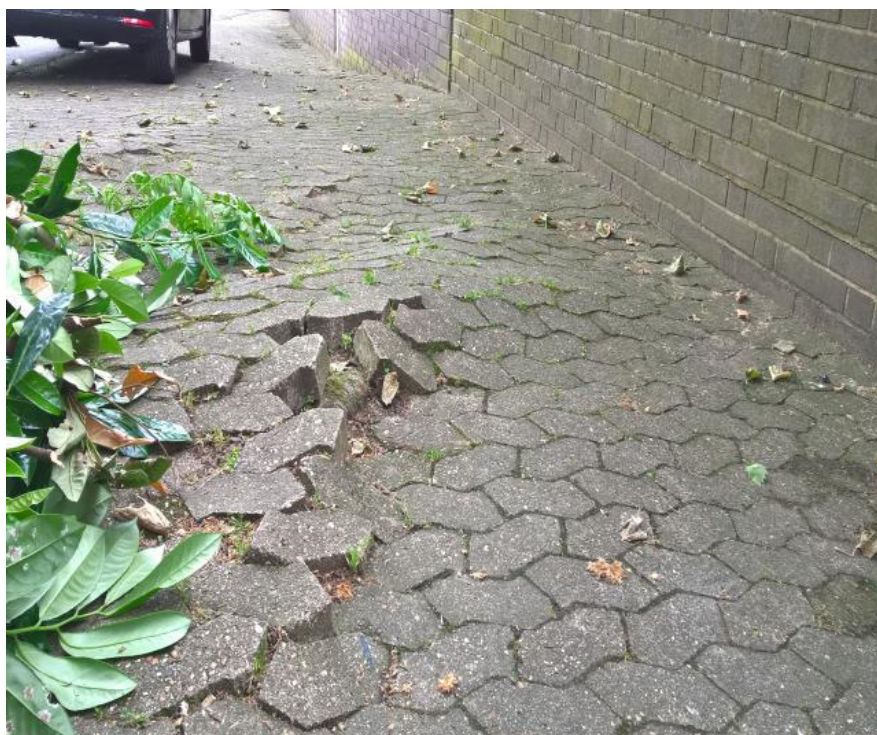
- In addition to the above works, the grounds would benefit from upgrading, the footpaths are in very poor condition, as are areas of retaining walls to some of the landscaping. I would suggest an additional £400,000 be allocated for this purpose.

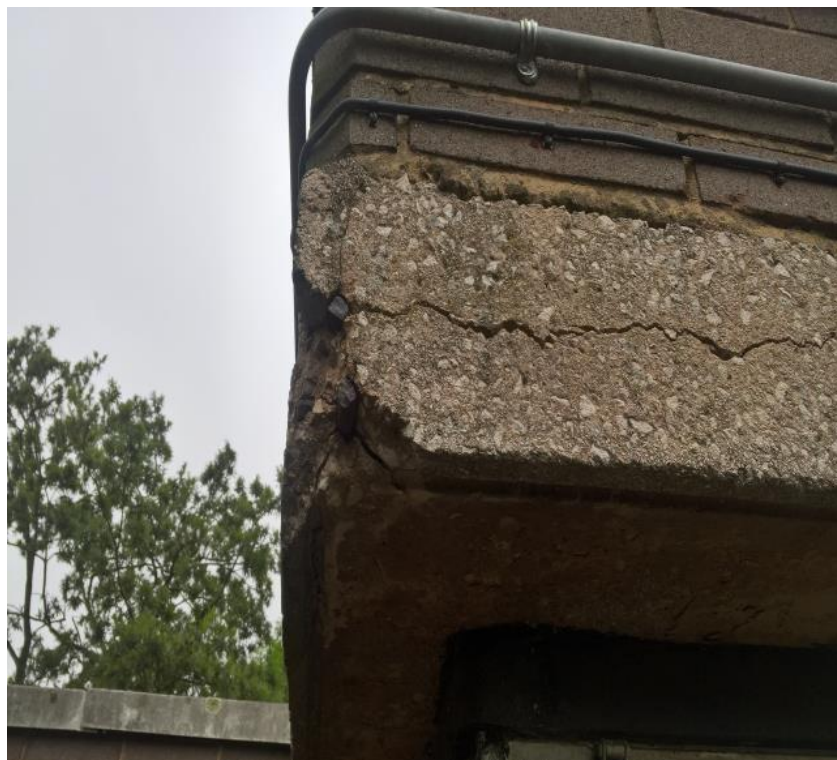
In addition to the general works required, the Senior Structural Engineer has identified a number of issues which also need to be addressed whilst the scaffolding is in situ. See separate report.

There are a large amount of concrete repairs required to the balcony walkway edges that need to be carried out utilising the scaffolding for Major Works, estimated costs of which would be in the region of a further £1,500,000. A **total budget requirement would be in the region of £10,500,000** for the external and structural works.
