RESOURCE CENTRE

AT COBURG CRESCENT

ARBORICULTURAL ASSESSMENT

Arboricultural Impact Assessment

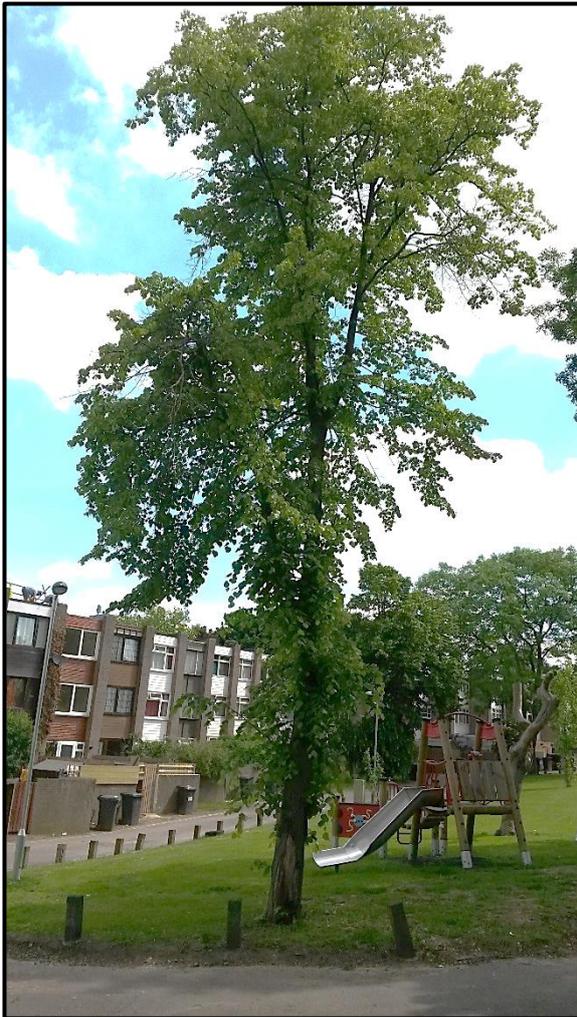
An individual tree T1, lime, was assessed as Category U, due to serious defects. As its location was next to a footpath and play area, removal is recommended for safety reasons.

Plate 1. T1, lime, located next to the play area and footpath. Viewed looking towards the north-east.

One tree T1, lime, was recommended for removal for reasons of poor condition. It is also recommended that major deadwood is removed from G1, lime, within six months of the survey date.

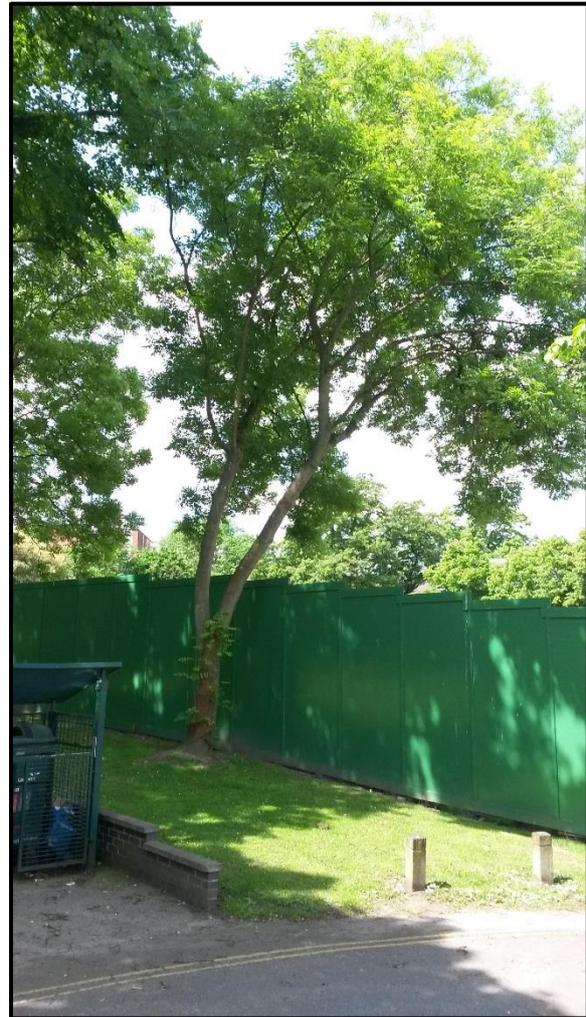
Plate 2. T2, ash, showing location next to hoardings surrounding construction site.

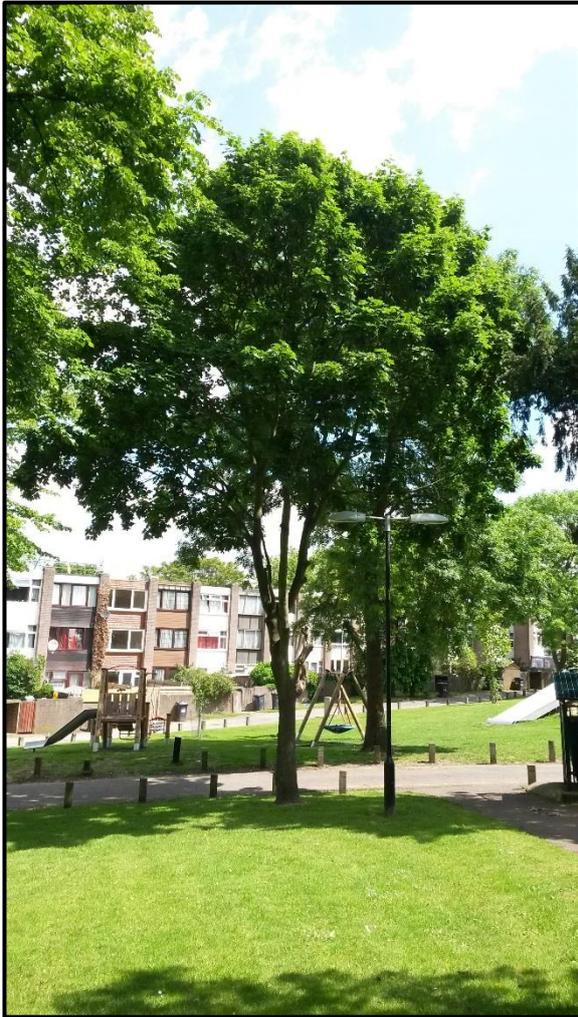
Plate 3. T3, Norway maple, located at the edge of the grassed amenity area. Viewed looking towards the east.

6.6 Provision of New Wall Foundations Within the RPA of T3

Hand excavation must be used for the initial 600mm depth, to minimise the potential for root damage. Where roots below 25mm diameter are encountered, these shall be cut using a clean, sharp saw. In the event that roots exceeding 25mm diameter are encountered, no severance must take place without first consulting the Project Arboriculturist, to assess the impact of removal on tree health and stability. All excavation and root severance should be supervised by the Project Arboriculturist.

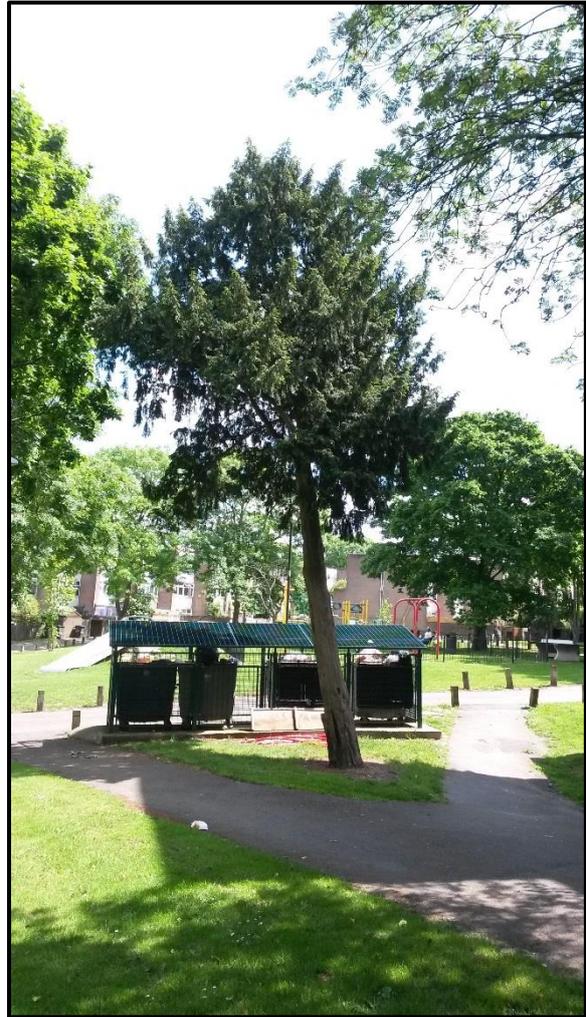
Plate 4. T4, yew, located next to the footpath and bin storage area. Note main stem leaning to the north.

Tree No.	Species	Age	Con	Height (m)	Spread (m)				Crown Clearance (m)	DBH (mm)	Comments	PRF	Recommendations	BS 5837 Category	Remaining Contribution (est.)	RPA Radius (m)
					N	S	E	W								
T4	Yew	EM	G	10	4	4	4	4	4.0	400	Intermediate tree of good extension growth and crown density leaning at 13 degrees to the north at 1.5 m. Several areas of longitudinal partially occluded bark damage up to 1m in length at the base to the east. Numerous unoccluded pruning wounds up to 150 diameter up to 5 m to the south and east	N	No work required.	B1	20-40	4.80
G2	Mountain ash	M	F	9.0 Max.	4	4	4	4	2.0	260 Max.	Pair of intermediate trees with mutual crown formation of fair extension growth and crown density. Severe unoccluded historic bark damage up to 30 x 60 cm square to the south-west of the most northerly tree. Unoccluded pruning wounds with decay at base up to 100 mm in diameter. Moderate (25 to 100 mm diameter) deadwood up to 6m in length in crown.	N	No work required.	C2	10-20	3.12

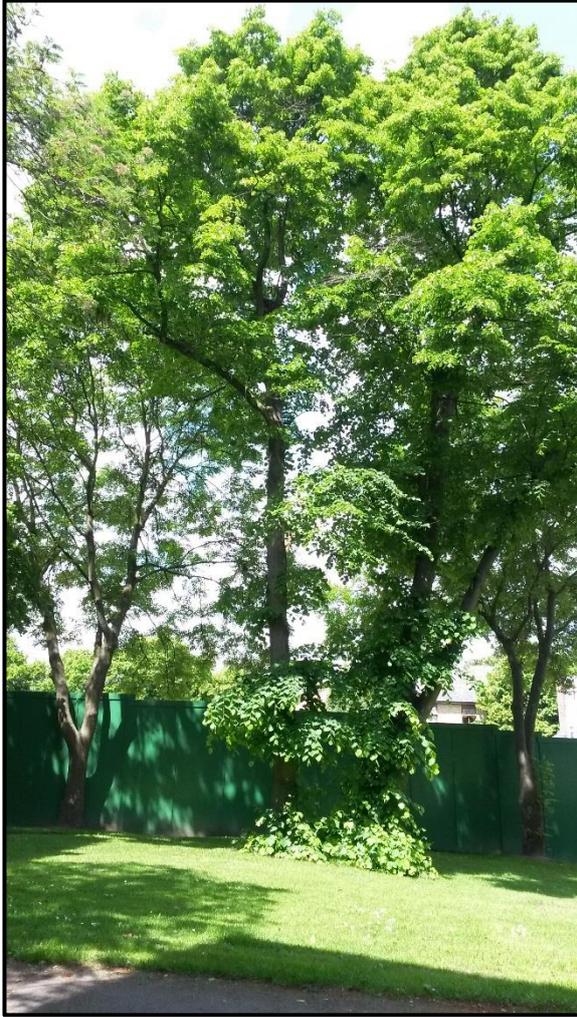
Plate 5. G1, lime (centre) and part of G3, lime, (far-left), showing proximity to the site hoardings. Viewed looking towards the west from the grassed amenity area.

G3	Ash Lime	EM	G	14 Max.	5	5	5	5	2.0	430 Max	Pair in intermediate trees with mutual crown formation of good extension growth and crown density, located close to sire hoarding. Ash forms two stems with U-shaped union at 2 m, with occluded wound at base up to 200 mm in diameter. Lime has longitudinal bark damage 60 x 10 cm, partially occluded at 0.3 m from base.	N	No work required.	B2	20-40	5.16
G4	Norway maple	EM	G	14 Max.	5	5	5	5	3.0	360 Max.	Intermediate group of three trees with mutual crown and good extension growth and crown density. Coalescing unoccluded pruning wounds, up to 150 mm in diameter, at 3m to the south-east on most western tree, longitudinal partially occluded bark damage at 170 x 10 cm 0.4m from base.	N	No work required.	B2	20-40	4.32
G5	Lime	EM	G	18 Max.	8	8	8	8	0	490 Max.	Pair of intermediate tress of good extension growth and crown density with dense epicormic growth at base. Minor (25 mm diameter) in crown. Most northern tree forms two stems at 6 m with a U-shaped union.	N	No work required.	B2	20-40	5.88

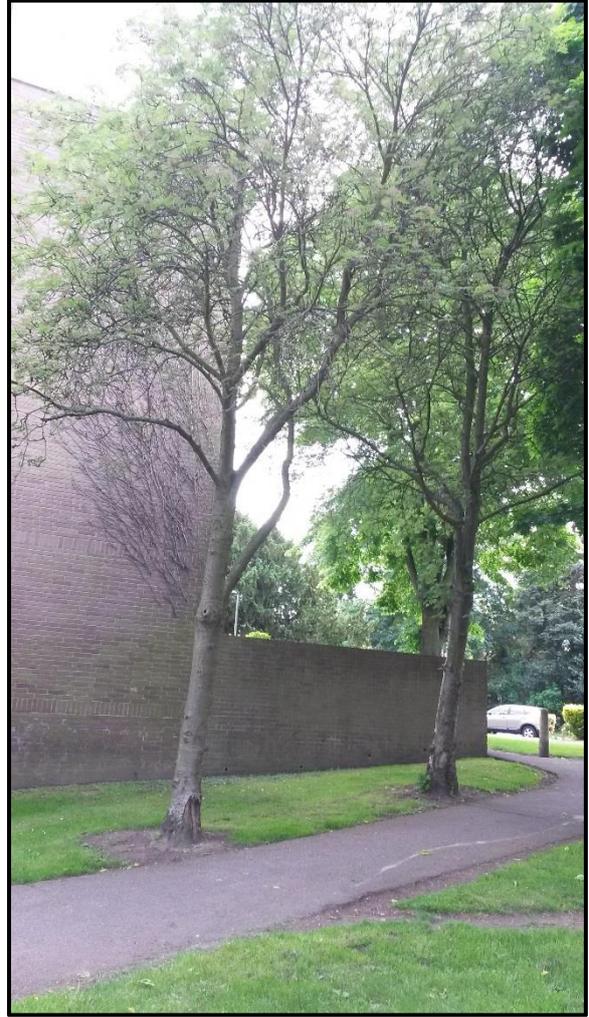
Plate 6. G2, mountain ash, showing located adjacent to the footpath and damage at the base of the most northerly tree.

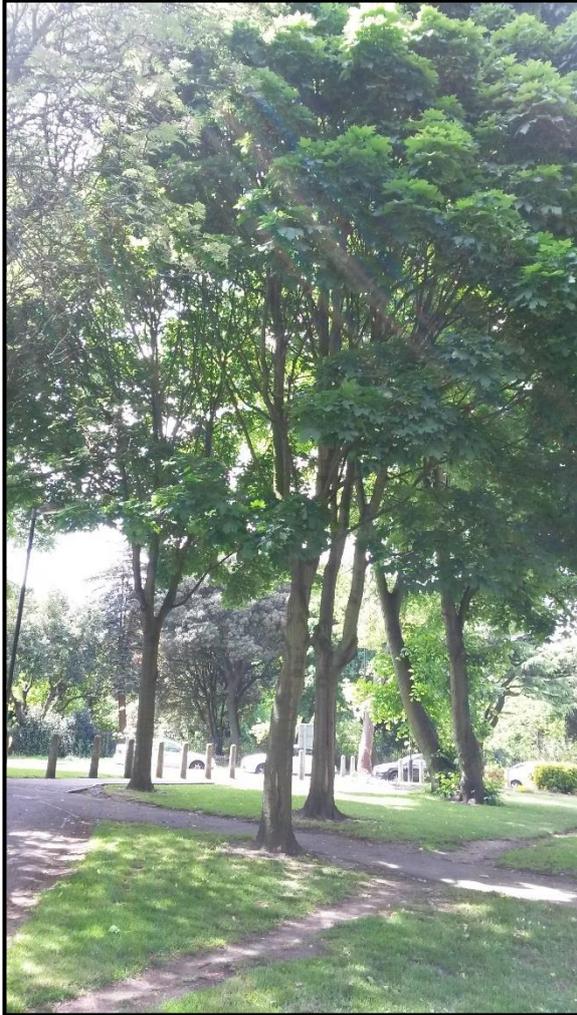
Plate 7. T5, ash (centre-left), G4, Norway maple (centre), and G5, lime (centre-right), showing close proximity of trees and canopy merging.

Tree No.	Species	Age	Con	Height (m)	Spread (m)				Crown Clearance (m)	DBH (mm)	Comments	PRF	Recommendations	BS 5837 Category	Remaining Contribution (est.)	RPA Radius (m)
					N	S	E	W								
T5	Ash	EM	F	16	6	6	6	6	2.5	360	Intermediate tree of fair extension growth and crown density, with sparse canopy and minor deadwood particularly to the south-west crown.	N	No work required.	B1	20-40	4.32
T6	Turkey oak	M	G	20	9	9	9	9	2.0	800*	Dominant tree of good extension growth and crown density. Unable to assess base of tree due to location behind fence. Numerous fully occluded pruning wounds up to 400 mm diameter.	N	No work required.	A1	40+	9.60
G6	Lime	EM	G	10	4	4	4	4	1.5	270 Max.	Intermediate group of trees with mutual crown formation and good extension growth and crown formation.	N	No work required.	B2	20-40	3.24
T7	Holly	EM	F	6	2	2	2	2	0	110 90	Intermediate tree of fair extension growth and crown density with dense epicormic growth at base.	N	No work required.	C1	10-20	1.68

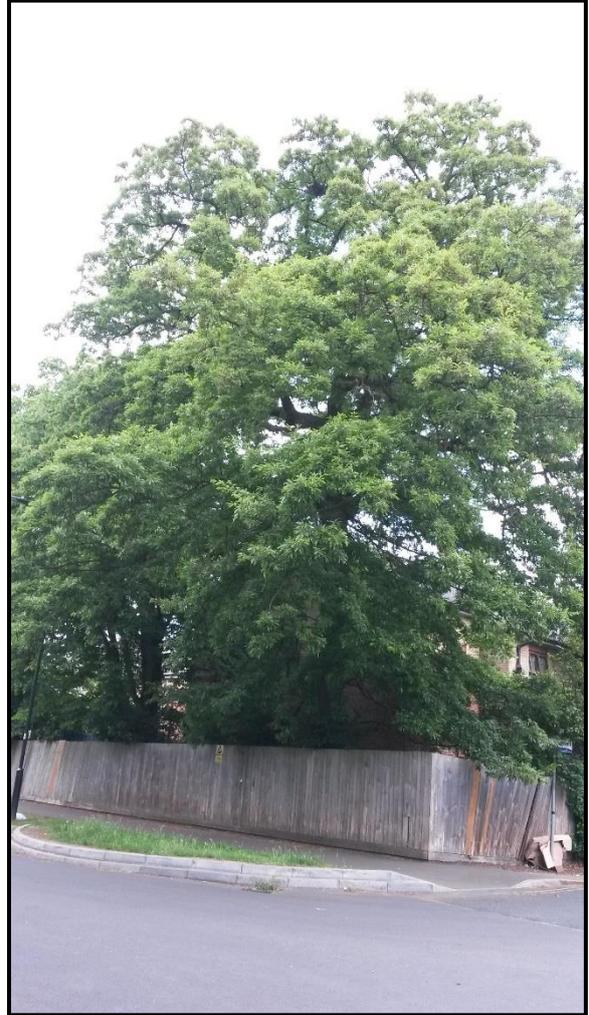
Plate 8. T6, Turkey oak, showing off-site location behind wooden boundary fence and excellent form and condition. Viewed looking towards the north from Palace Road.

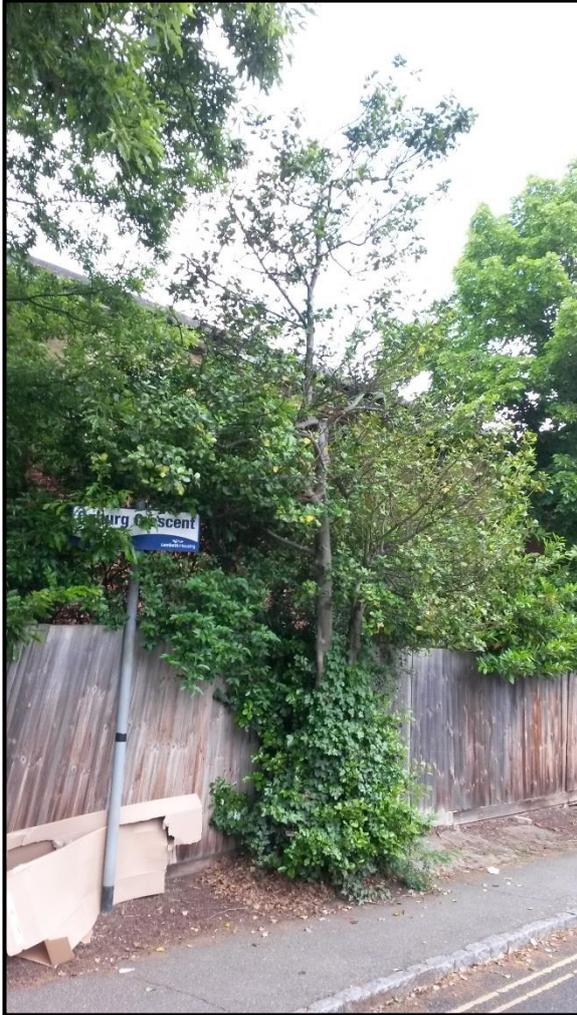
Plate 8 (left). T7, holly, showing location below the canopy of T6, Turkey oak. Viewed looking north alongside Coburg Crescent.

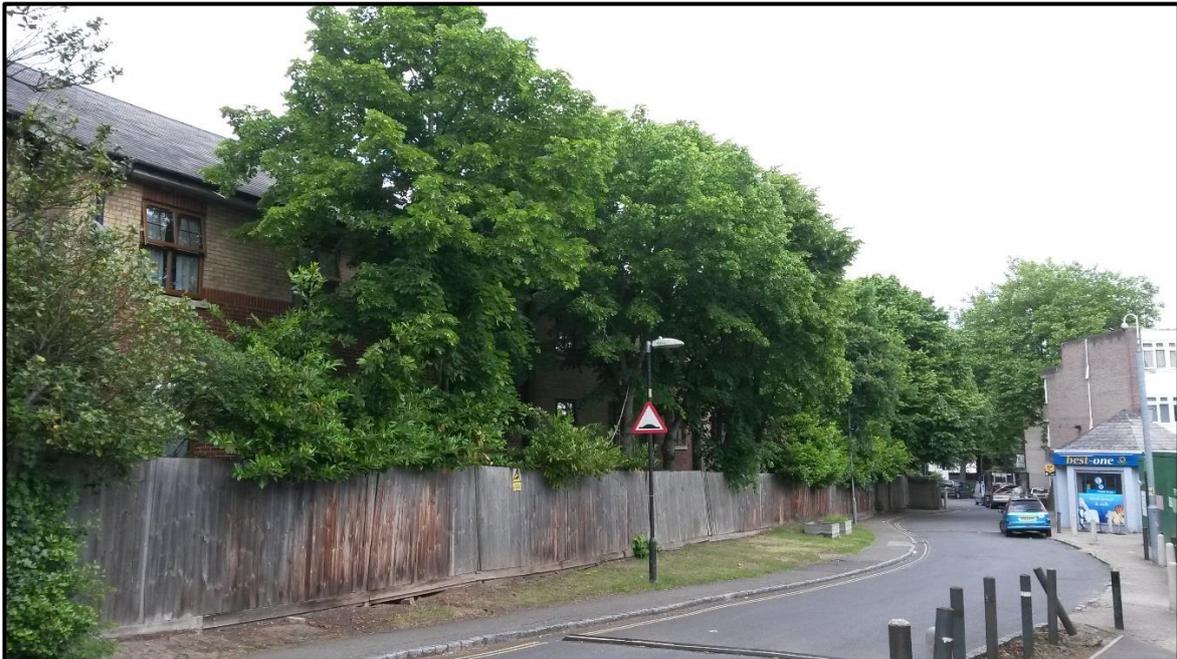
Plate 9 (below). G6, lime, showing dominant position alongside Coburg Crescent.

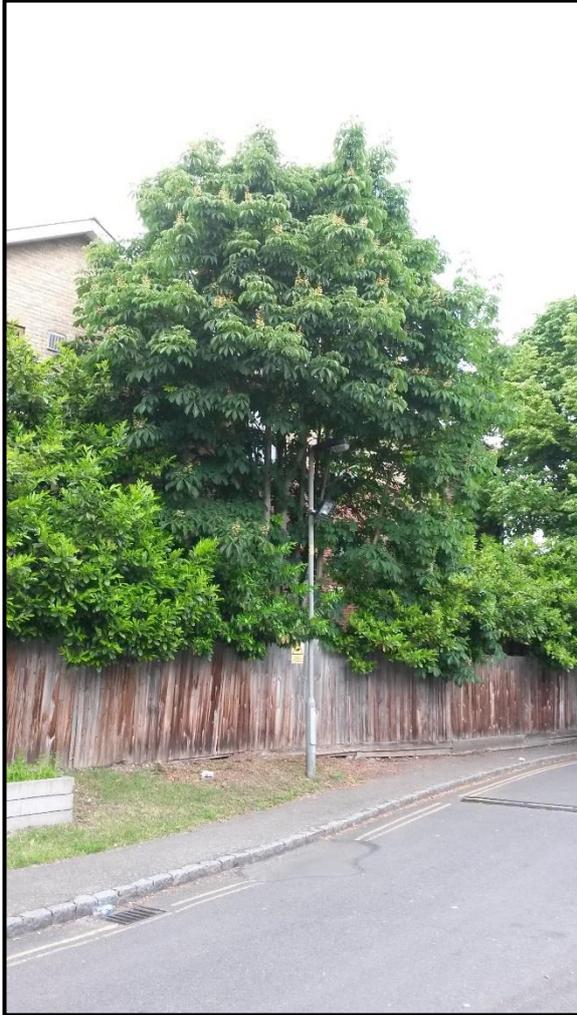
Plate 10. T8, horse chestnut, located to the north-west outside the site boundary. Note multi-stemmed form and location behind wooden fence. Viewed looking north-west from Coburg Crescent.
